Access Corridor

P.1 – Method/Preparation

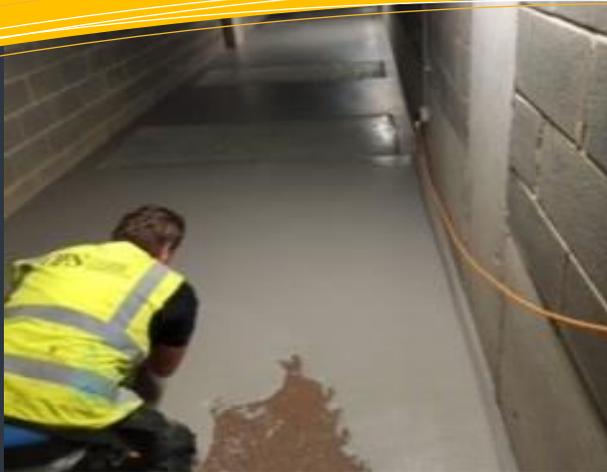
Top Image:

Our team are on site hand laying the system to attain an excellent finish.

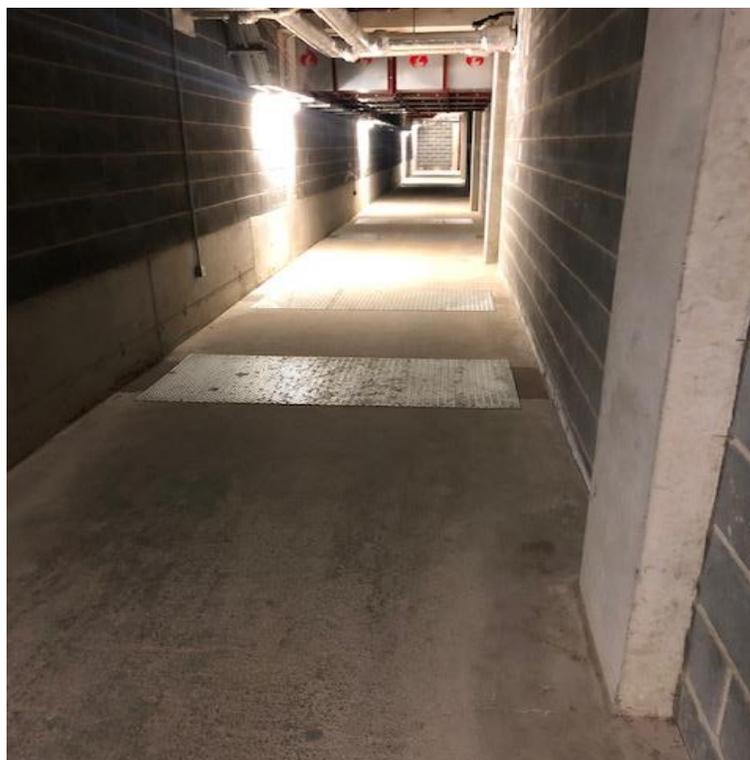
Bottom Image:

This is a photo of one leg of the corridor, it branches off into 2 other sections, totaling just under 400m² in size.

The screed laid was failing and cracks were starting to appear in various areas. As a quick fix the client had installed checker plates in an attempt to protect the joints from cracking further. A decision was made by the client to leave the checker plates in, so our team started to mechanically grind the floor to clean and texture the substrate. We then installed 20mm x 20mm saw cuts around all checker plates and stantions, the hand laid material will fill these holes and cure, gripping the floor like an anchor point.

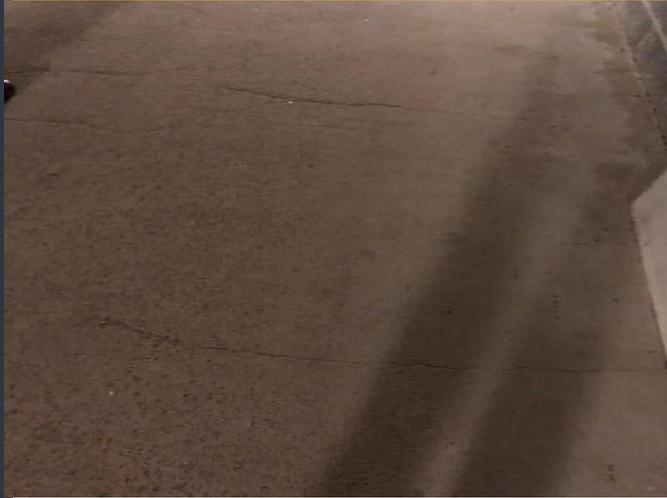
Top Image:

This photo shows some of the cracks that had appeared and why the client called us in.

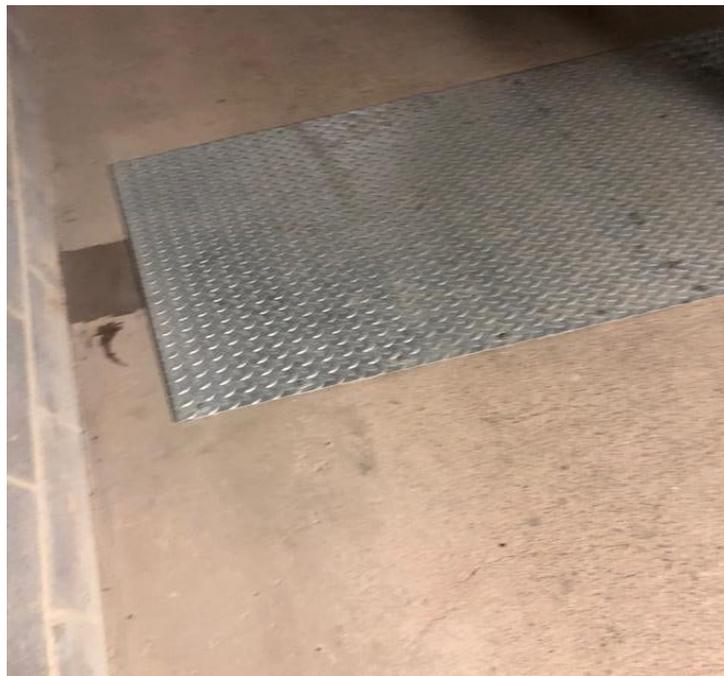
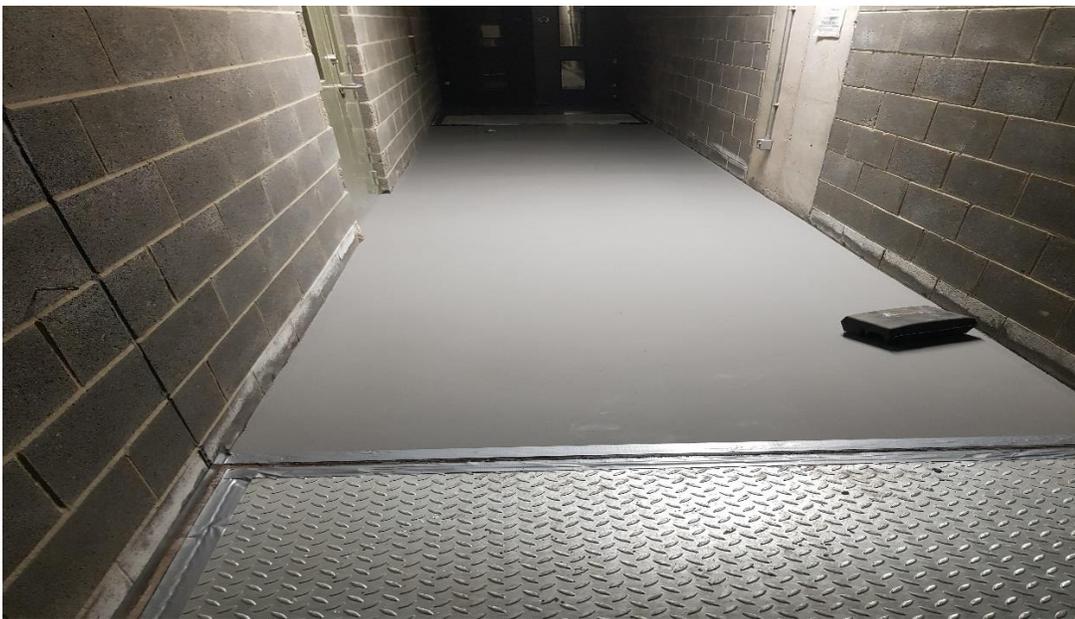
Top Image:

The improvement is already here to see before our team finishes off the details around the checker plates.

Our team installed extra 10mm x 6mm chase cuts at the door thresholds, then used a hand grinder to grind the area in front of where we installed the chase cut, to ensure the material sits flush with the existing concrete, eliminating and trip hazard. Next, we repaired and replaced the joints using a rubber re-enforced polyurethane joint and arris repair mortar, and then installed a DPM incorporated with aggregate to provide a mechanical key for the following system.

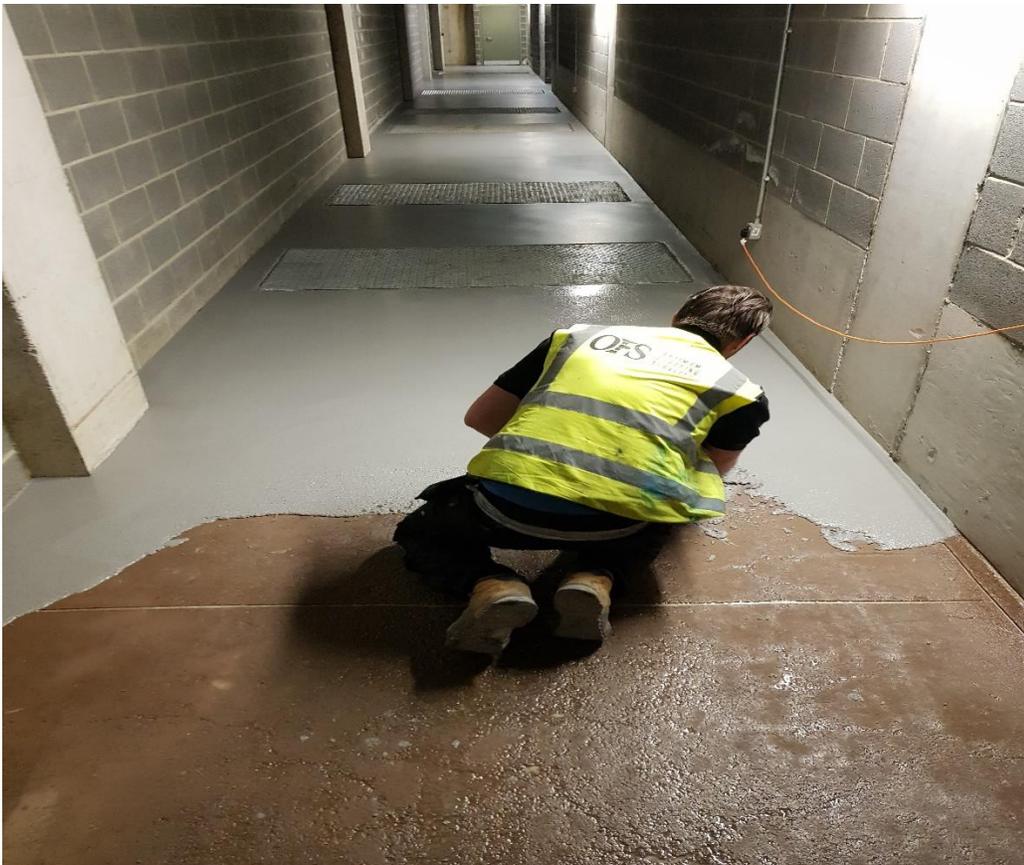
Bottom Image:

This is a great money shot of our team on site hand laying the 6mm polyurethane screed.

Once the DPM had been installed and an aggregate scatter laid, our team moved on to installing 6mm polyurethane screed, hand laid by the use of a steel float trowel as shown below. This system was ideal for the client with its chemical resistance, slip resistance and durability ticking all the necessary boxes. Once laid we then saw cut a 10mm x 6mm expansion joint around the perimeter of all checker plates and installed more jointing compound, introducing an extra joint would give more flexibility and security against cracking around the checker plates.

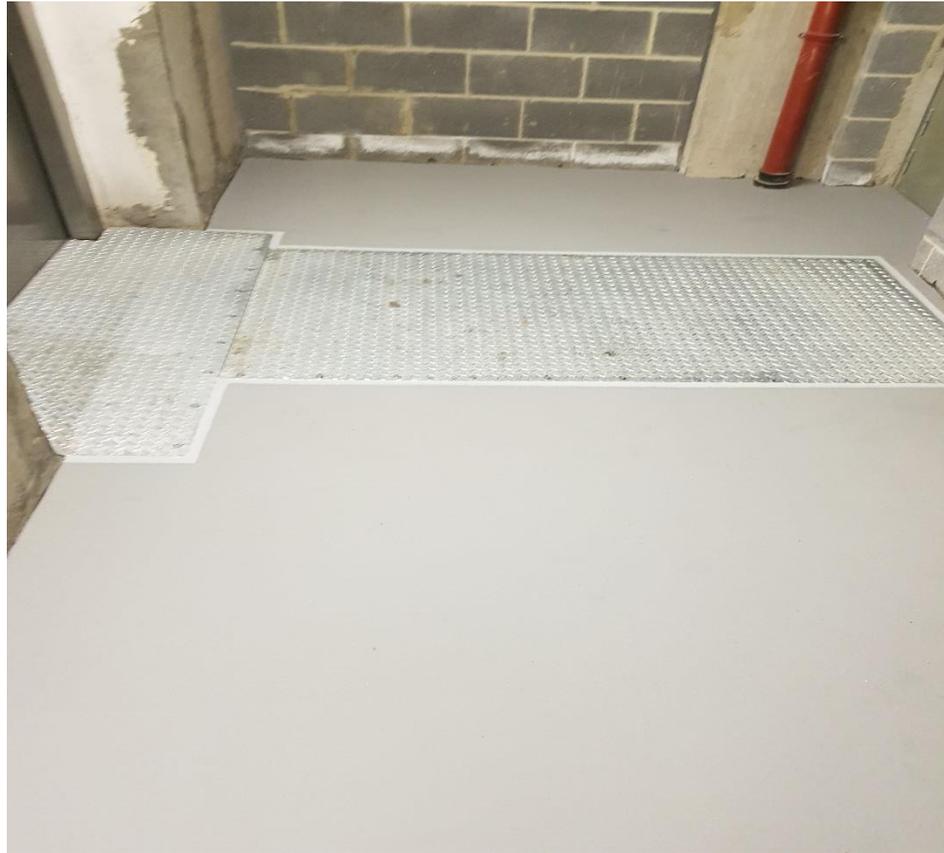
Image:

The finished floor and joints look really good, ready to provide a better working environment for the client.
