### P.1 – Method/Preparation

Optimum Flooring were called in to have a look at this job as the floor had been damaged as a result of a fire. The whole floor area of around 1800m<sup>2</sup> needed a revamp but first our team focused on the areas of damaged floor as shown below. We started by digging out the area most affect by electric kango machines to a depth of 30mm, then we primed the area with a scatter of aggregate before pumping in a deep fill smoothing compound to a depth of 30mm. Once this had cured we applied a clear epoxy seal coat over the top, ready for our works to the whole of the floor area.

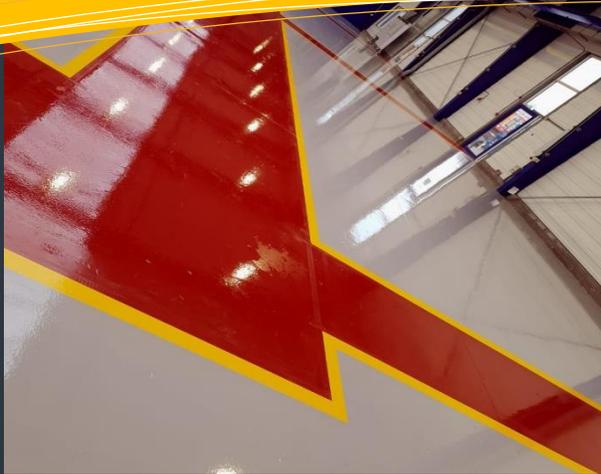
The finished floor looking ten times better than it did before works started.

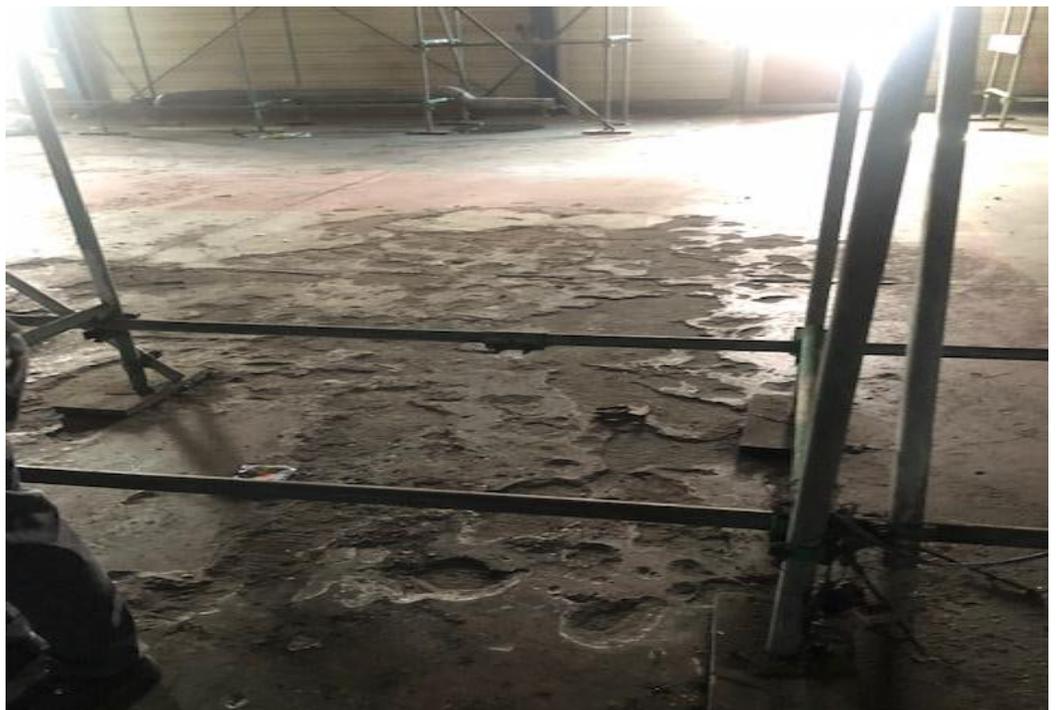
This photo shows the area of the floor most damaged by the fire, and the first area of focus for our team.

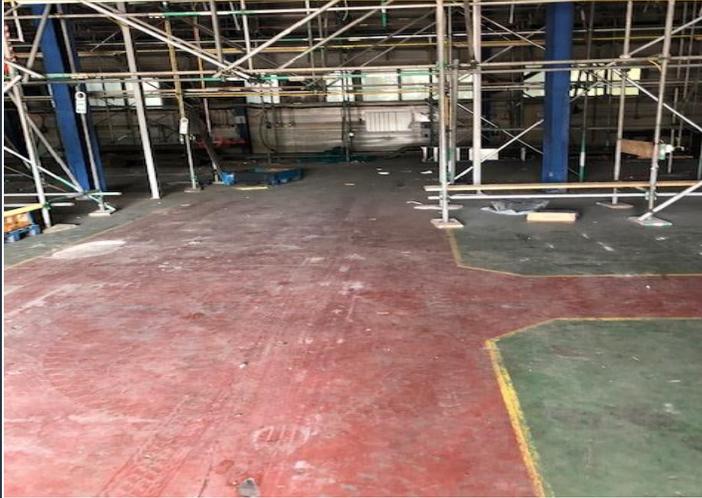
Here we have a photo from our first site visit, showing the floor before our works.

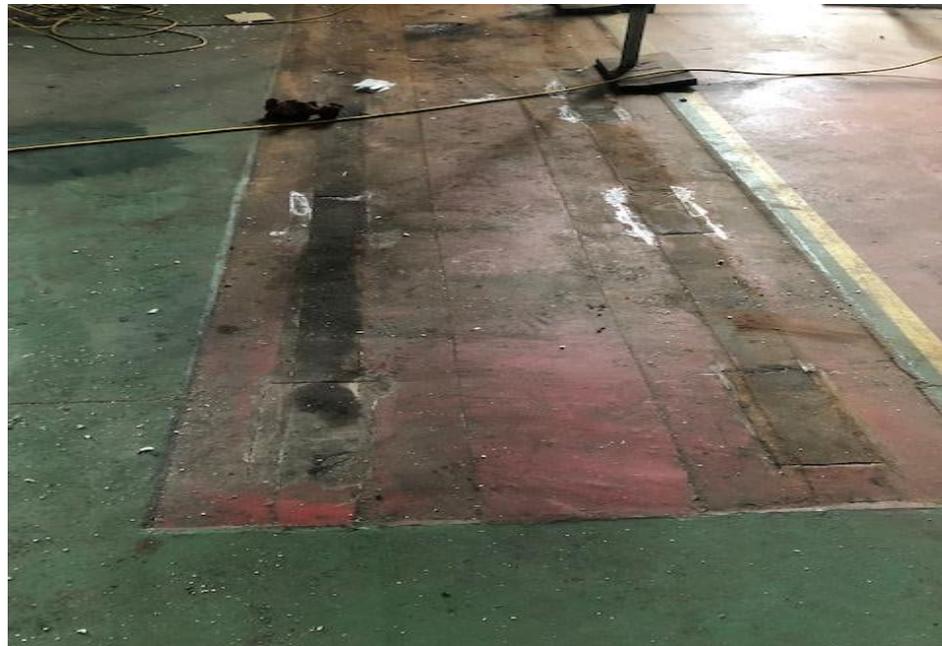
Once the floor had been repaired, our team mechanically ground the whole area, this photo was taken at the end of our prep stage.

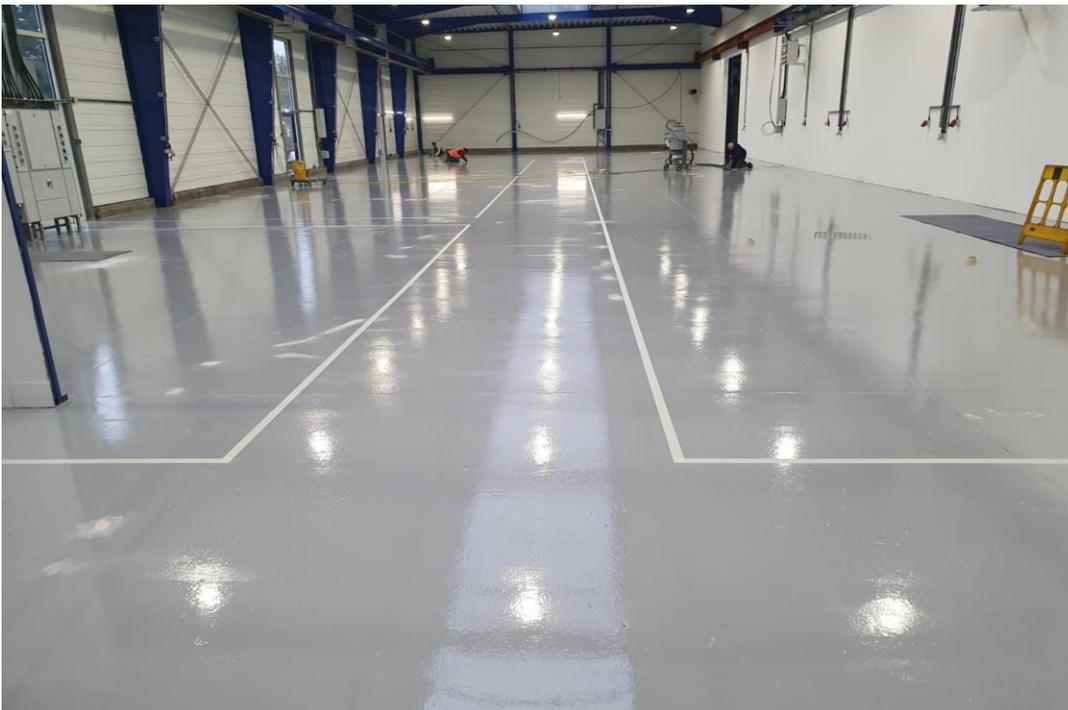
The finished floor here, exactly what the client was looking for, making the whole place look so much better.
