Kitchen Floor

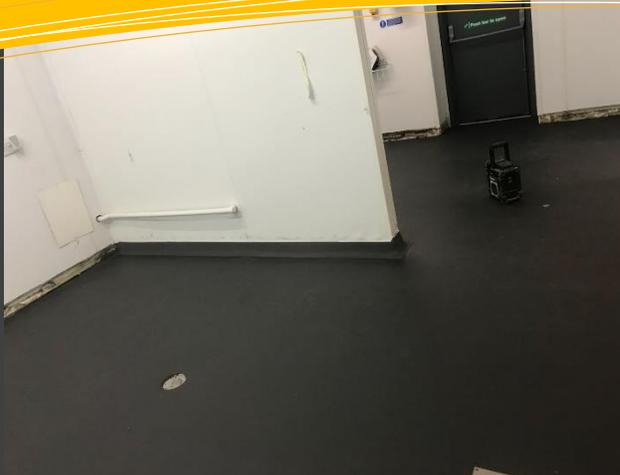
Top Image:

Our team are in the process of completing the covings.

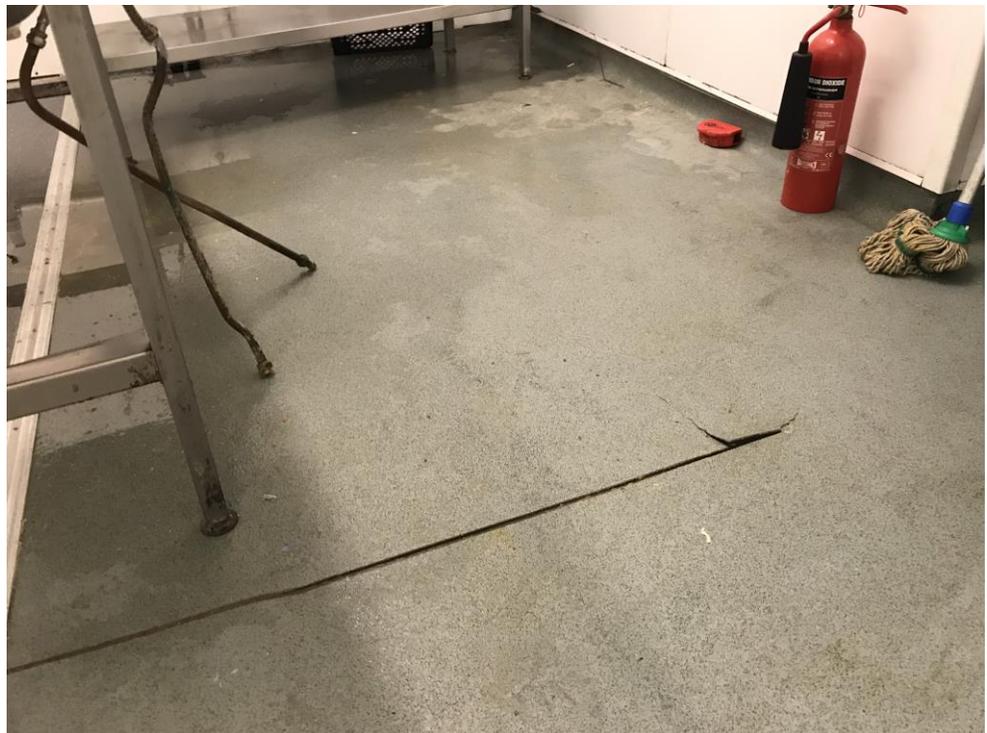
Top Image:

This photo shows how the current floor was failing creating slip hazards in addition to the hygiene problems.

This photo shows an overview of the floor before works commence.

As shown below the old kitchen floor was vinyl sheeting so our team first had to remove this using a mechanical tile lifting machine, once done we used a remote controlled three-phase Scanmaskin grinding machine to remove any glue and laitance, following by the use of mechanical hand tools to clean and texture the substrate ready for application.

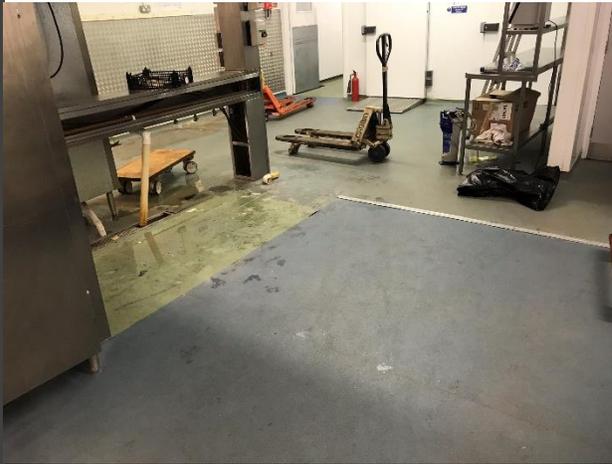
Bottom Image:

Below is a photo of the stainless steel trim detail used on this project.

Firstly our team saw cut around all perimeter edges and drainage channels to create anchor points, which the system will grip into during chemical cure, thus strengthening the floor. Next we would supply and fix a stainless steel trim 150mm high on each wall by mechanical fixing with a mastic seal, this allows the coving to finish nicely to a trim.

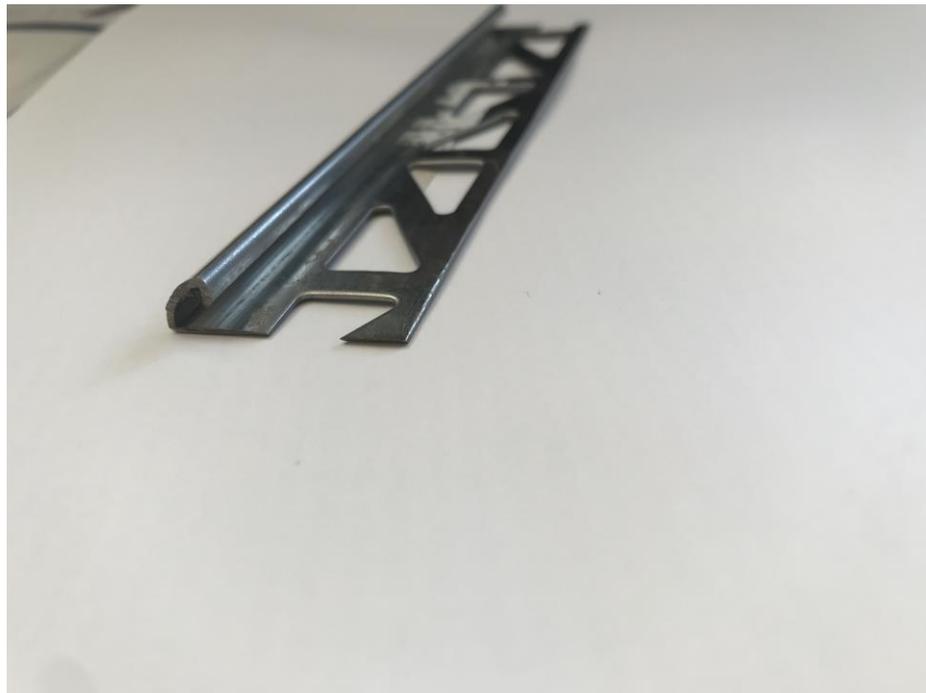
Top Image:

Here the floor has been installed, next our team move onto the coving.

Once the stainless steel trims were in place, our team focused on the main floor area, here we applied Resdev Pumadur HF at a nominal thickness of 6mm, this seamless, slip resistant, highly chemical resistant floor screed was a massive improvement from the old worn vinyl sheeting. Once completed our team then looked to the coving and first applied Resdev Pumaprime TC which is a tack coat primer allowing screeds to be applied wet on wet giving a monolithic bond. Next we applied Pumadur CG to form the coving and then coated with Pumadur TF, a water-based, high-build polyurethane coating in the same colour as the floor.

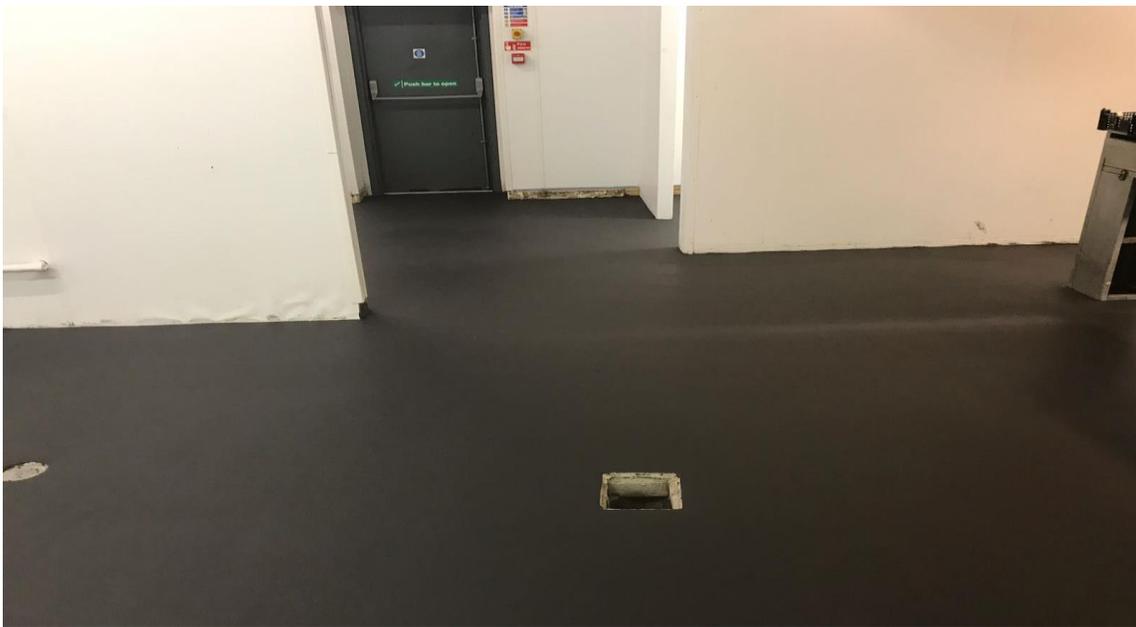
Bottom Image:

Here the coving is being installed as described in the application/installation to the right.

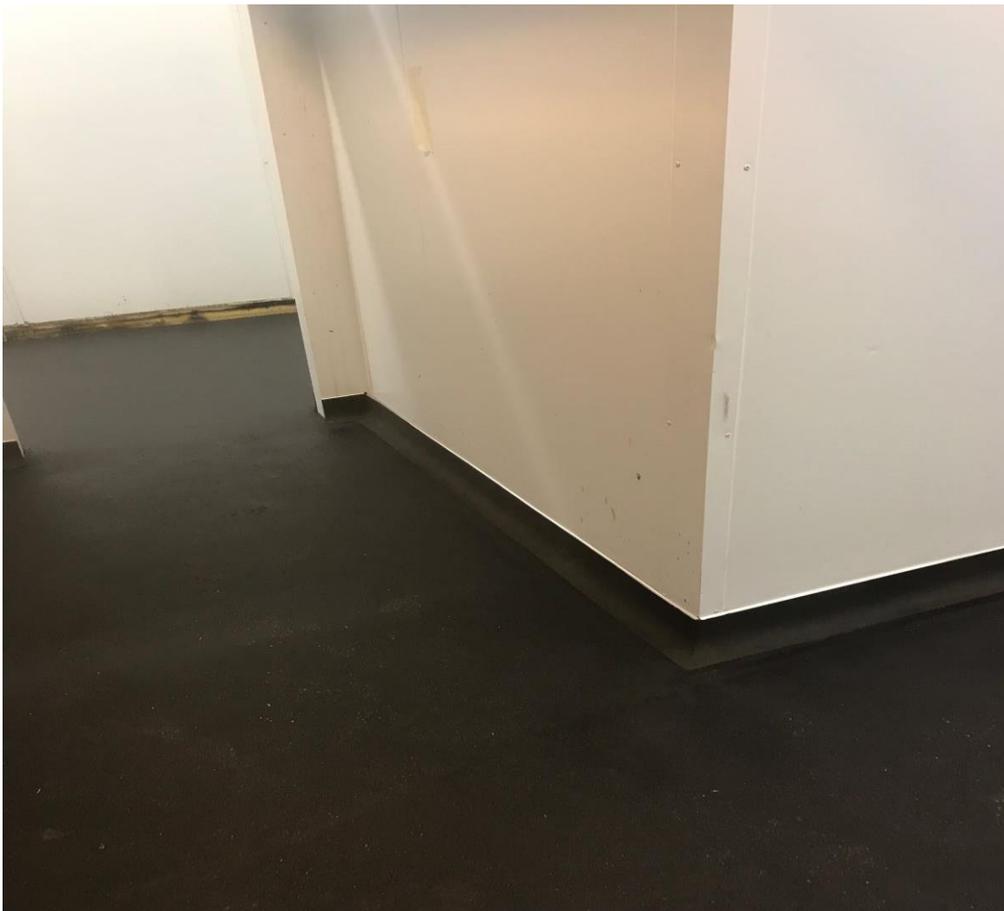
Image:

Looking at the new floor side by side with the old floor really speaks volumes as to how the whole kitchen has benefitted from a much needed upgrade.
