# Meat Factory

## P.1 – Method/Preparation

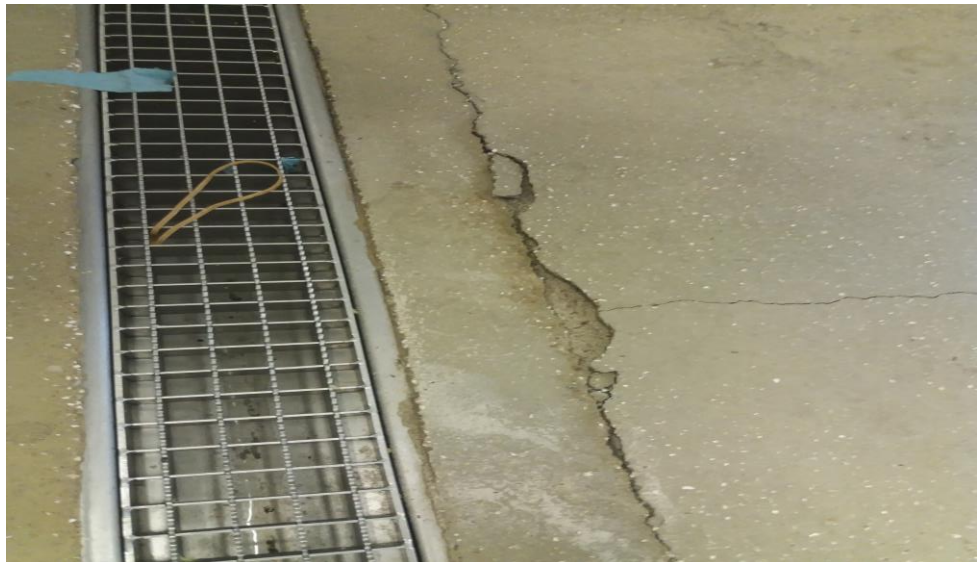
### Bottom Image:

The image below shows the state of the floor before our works commenced.

On this job the current system had been down for long time and the floor needed replacing. Our team saw cut around the areas of damaged screed using a Hilti-floor saw with fitted vacuum attachments, then we broke out the floor using an electric kango machine. Once this step was completed, we mechanically grinded the floor using a three-phase grinding machine, again with fitted vacuum attachments to keep airborne dust to a minimum.

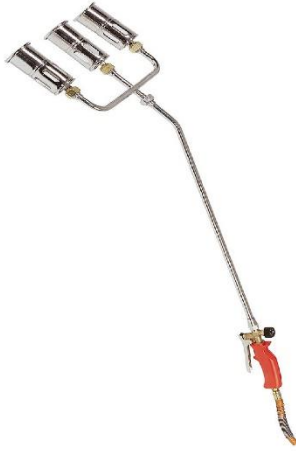
### Top Image:

This is the propane gas burner we used to force dry the floor.

Once we took up the floor, we discovered the sub-floor was damp, giving sense to why the current system was cracking under the moisture content below. Because we were on a strict time frame with the client, and already working through the night, our team had to introduce a propane gas torch to force dry the area to make it suitable to accept our system.

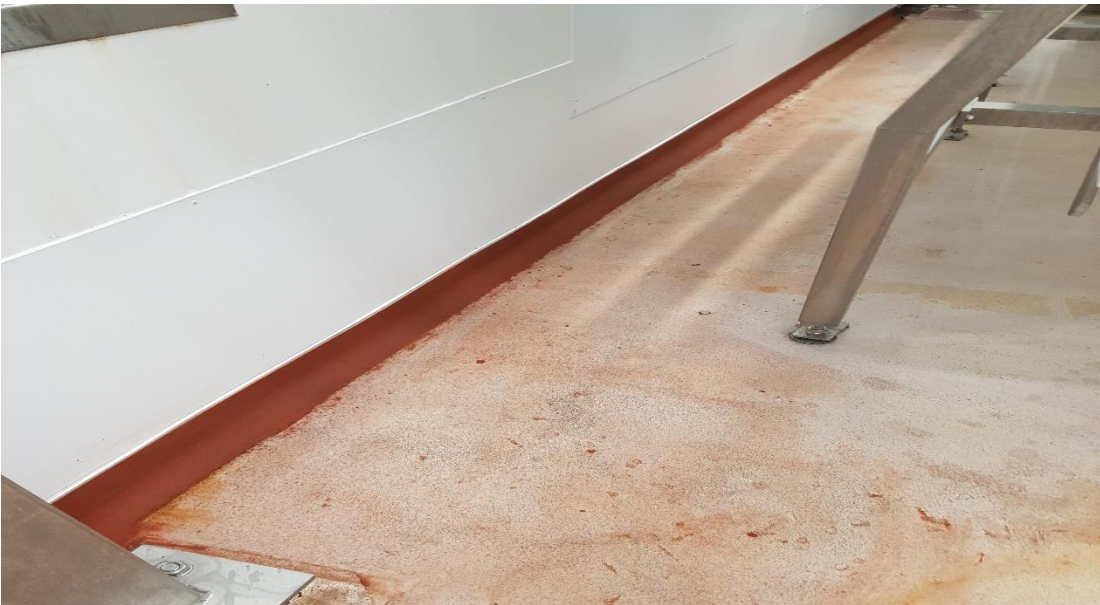
### **Top Image:**

Our team only painted the coving as the coving system was in good shape and didn't need replacing.

Next our team turned their attention to the coving. The current coving was in good condition and just needed a light grind and re-coating. Once completed we introduced saw cuts around all perimeter edges, drainage channels and stantions. We did this because when a polyurethane screed cures it shrinks, these saw cuts will then act like anchor grooves giving the system something to grip to during chemical cure, thus giving extra strength and flexibility in the long term. The final step was to install a 6mm polyurethane screed, this system is hand laid by a steel float trowel, and gives excellent abrasion, impact and chemical resistance. Its lightly textured finish makes the product ideal for both wet and dry processing environments such as the food, beverage and chemical industries.

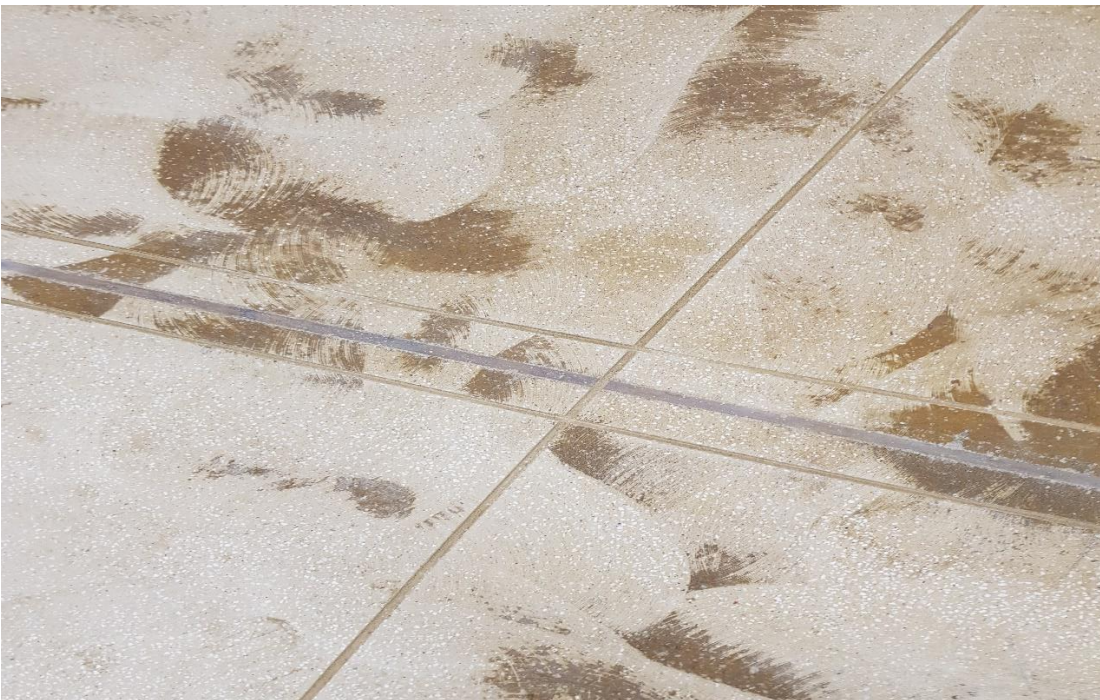
### **Bottom Image:**

Here's a great shot of the saw-cuts installed by our team to act as an anchor when the polyurethane screed cures and shrinks.

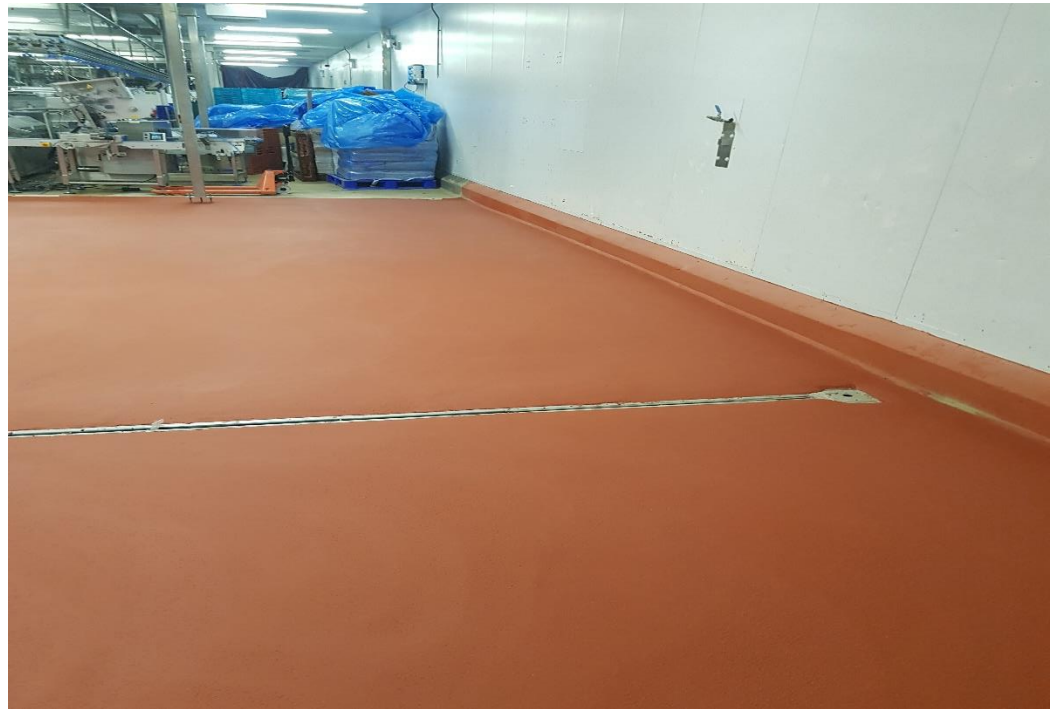
## Image:

The bottom image shows the area once our team had finished the project.

Our team completed this job during the clients shut down, working through the night and solving the issue of the damp floor with minimal impact on the job. Great work by the Optimum team!
