### P.1 – Method/Preparation

Optimum Flooring were called in to have a look at this job as the floor had been damaged as a result of a fire. The whole floor area of around 1800m<sup>2</sup> needed a revamp but first our team focused on the areas of damaged floor as shown below. We started by digging out the area most affect by electric kango machines to a depth of 30mm, then we primed the area with a scatter of aggregate before pumping in a deep fill smoothing compound to a depth of 30mm. Once this had cured we applied a clear epoxy seal coat over the top, ready for our works to the whole of the floor area.

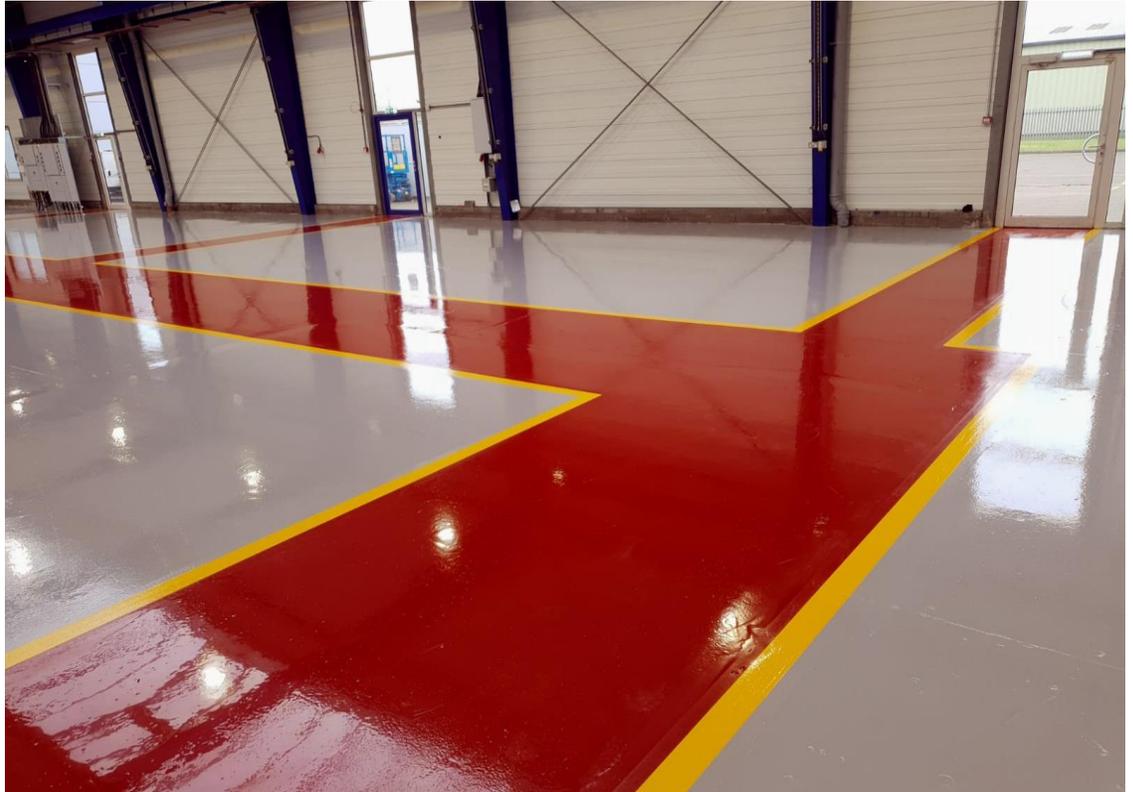
Our team finished on time, without any delays to give the client a finish they were more than happy with. Another good job completed by the Optimum team!
