Retail Outlet

P.1 – Method/Preparation

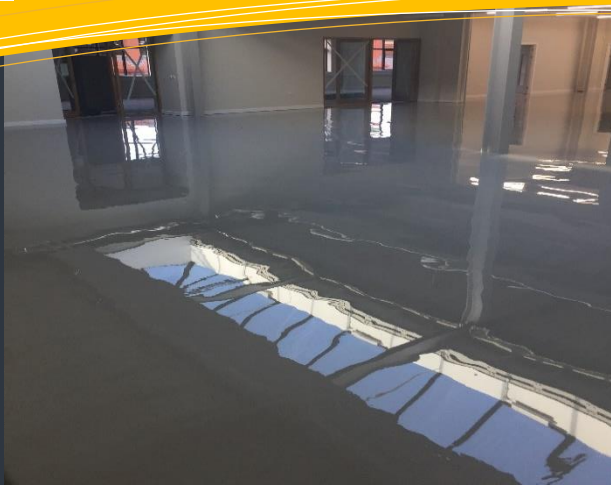
Top Image:

This Arturo self-smoothing floor not only looks spectacular, but also provides good acoustic qualities.

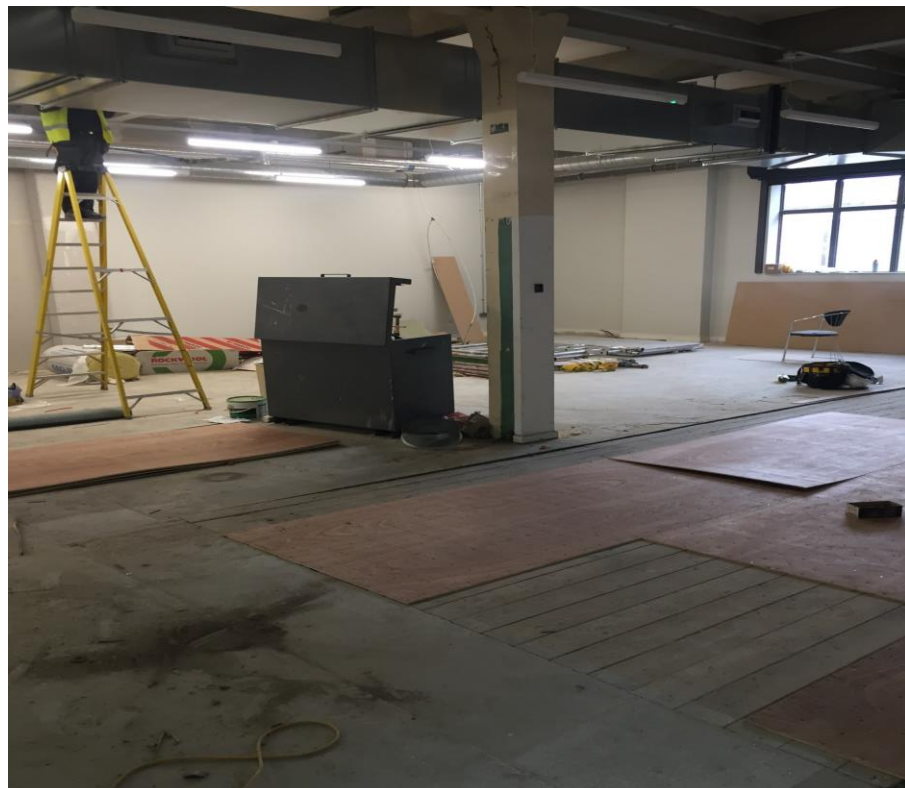
Bottom Image:

Here is where the floor boards were originally, our team advised that fitting marine ply and mechanically fixing this every 150 centres was the best solution to achieve the desired floor.

The original floor was far from ideal, in addition to repairs, some of the areas of the floor were made up from wooden floor boards as shown below. These needed to be overlaid using 15mm marine ply fixed every 150 centres, this would bring the floor level and accept the application of the system.

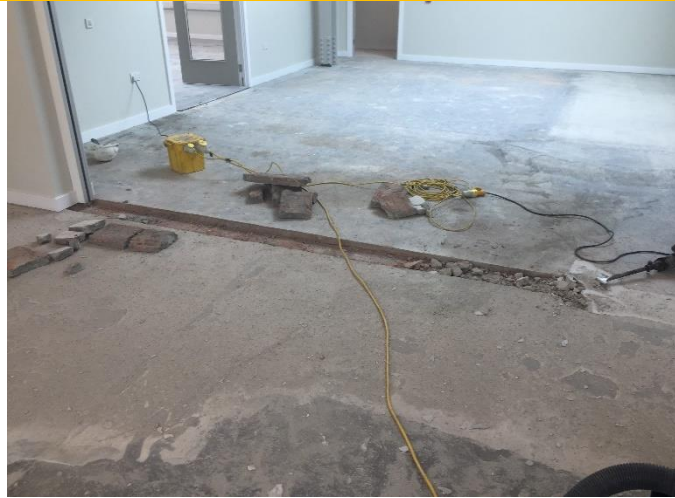
Top Image:

This area shows where further repairs were made using resin bulk to level the floor, ready for application of the primer and coating.

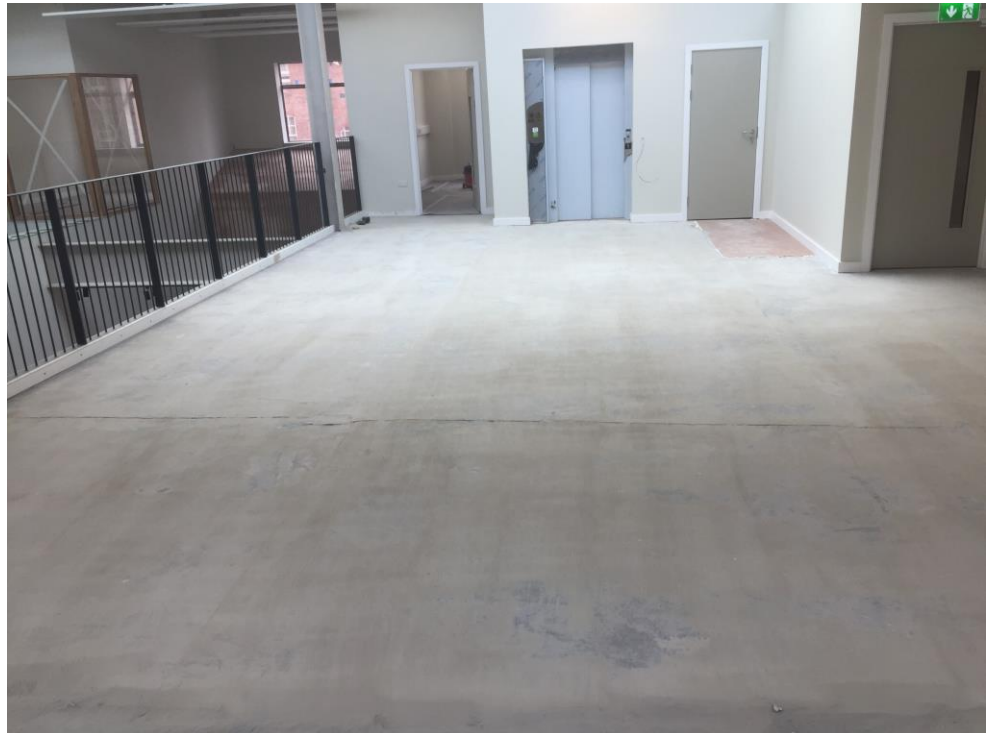
Top Image:

This shows the top floor once Arturo EP 6500 primer was applied.

Once the floor was prepared and repairs made where needed using resin bulk, we applied a solvent-free, two-component, epoxy-based Arturo primer. This was followed by Arturo PU3320, a coloured, two-component, water-borne, polyurethane based satin floor finish. To meet the clients needs we then applied Arturo PU 7900 to the top floor to give a gloss finish.

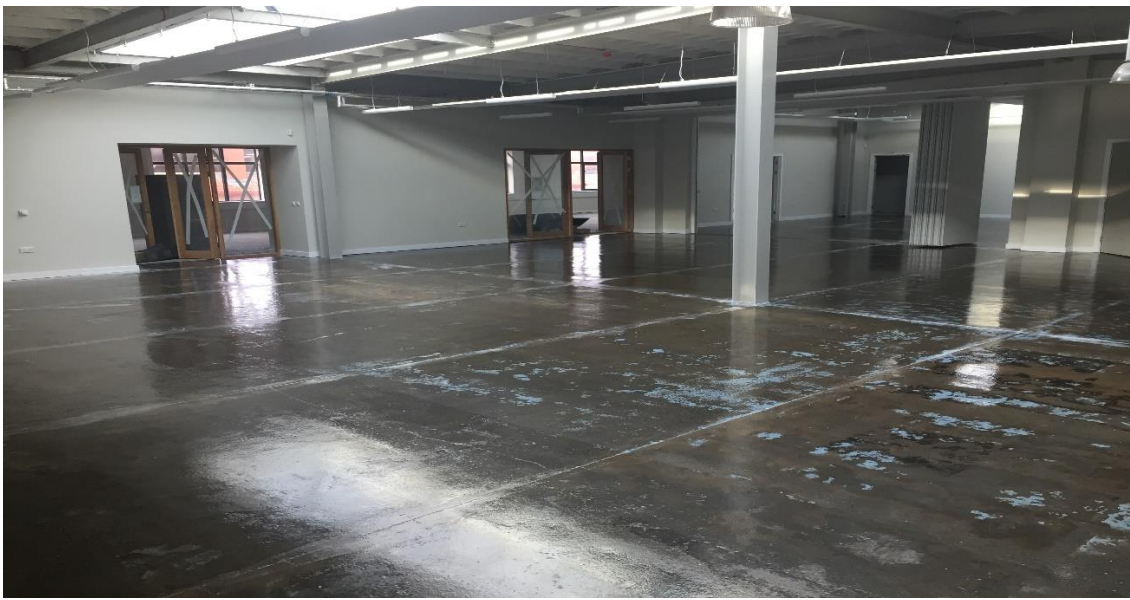
Bottom Image:

Here we have the top floor with Arturo PU 7900 applied to give a gloss finish.

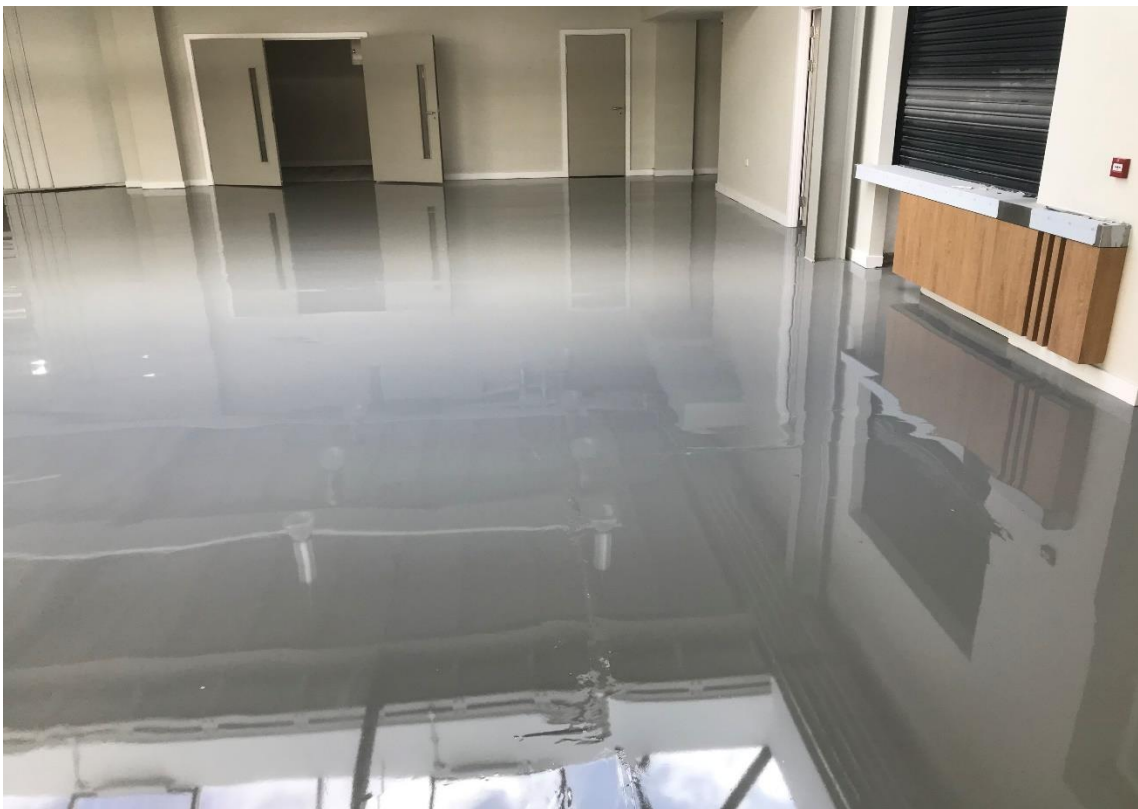
Image:

The bottom floor, once preparation, repair and primer stages had been completed, had Arturo PU3320 applied to give this satin finish.
